NO: 08-28-93

SUBJECT: 3.5L Engine Spark Plug Discoloration

DATE: Jul. 9, 1993

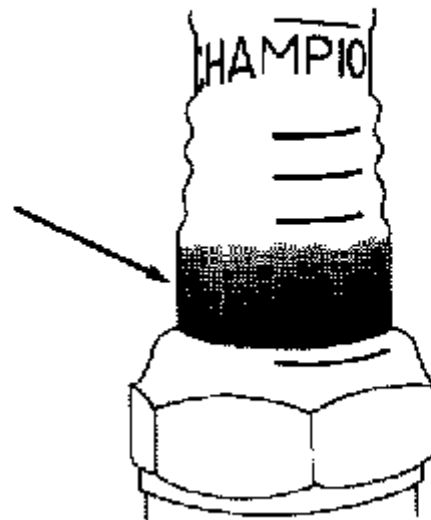
The brown stain on the spark plug insulator above the metal shell and below the spark plug boot is a common occurrence. This condition is not a defect and does **NOT** require the spark plugs to be replaced due to this appearance.

The ignition system generates a corona in the area of the spark plug not covered by the spark plug boot. The electrical capacitance of the spark plug creates an electrical field in the region of the spark plug. The electrical field generates ozone from the air. Ozone is a very active form of oxygen that will combine with ever present contaminants that form the harmless brown stain.

STAINING OF SPARK PLUG INSULATOR CAUSED BY REACTION OF OZONE (O₃) WITH CONTAMINATES IN THE AIR

THE HARMLESS BROWN STAIN FORMS ON THE INSULATOR ABOVE THE SHELL AND BELOW THE SPARK PLUG BOOT.
